Intel® Itanium® Processor

Specification Update

August 2002

Order Number: 249720-007

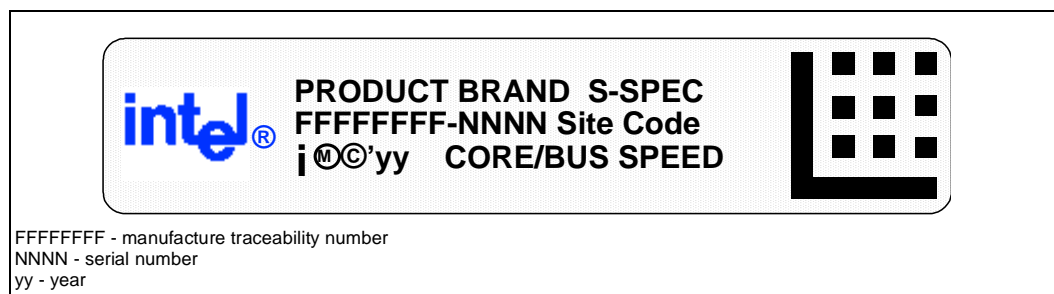
The cartridge mark for the product is a laser marked label attached to the end of the PAC418 cartridge opposite the power tab. The mark provides the following information:

- Product Brand Name
- Manufacture Traceability (including manufacturing lot and unit identification)
- Manufacturing Site
- Mask Work and Copyright Protection for the Processor and Cache Die
- Product Identification (including processor core speed, cache size, bus speed)
- Intel Company Logo
- Two-dimensional Product Identification Matrix (Intel internal use)
